# Evaluation Report 305

## Sperry New Holland Model 8500 Round Bale Wagon

# SPERRY NEW HOLLAND MODEL 8500 ROUND BALE WAGON

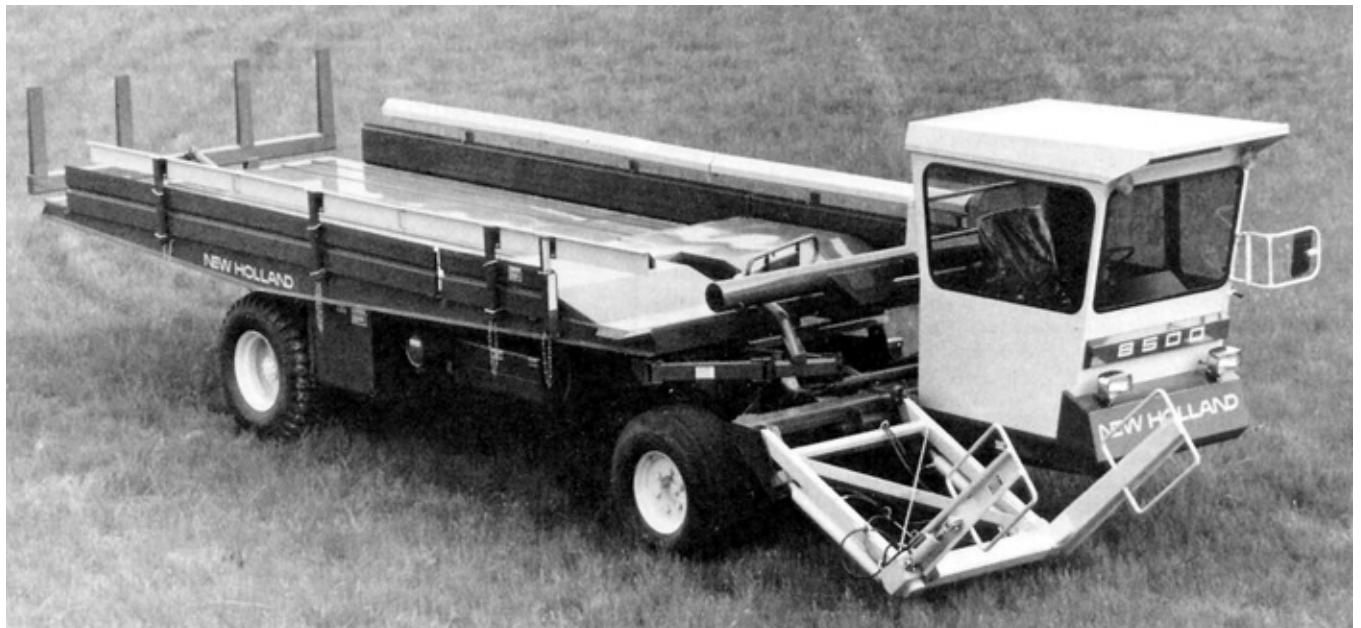
FIGURE 1. New Holland Model 8500 Round Bale Wagon: (1) Tailgate, (2) Load Deck, (3) Cross Conveyor, (4) Loader, (5) Pusher.

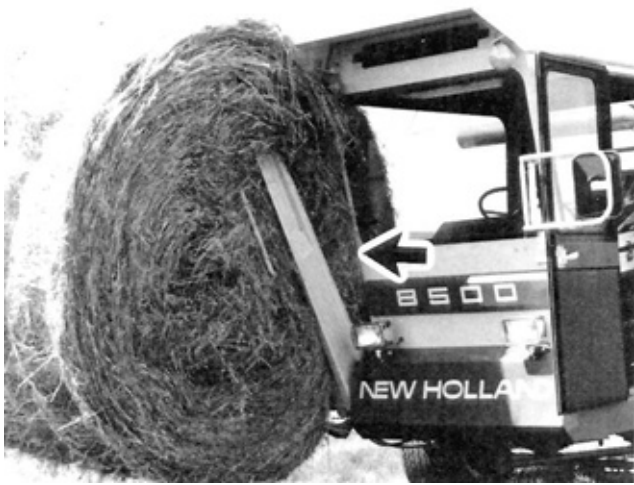
When loading loosely formed or poorly tied bales, the cross conveyor arm occasionally slipped beneath the bale and failed to push the bale to the left side of the load deck. When loading 72 in (1830 mm) diameter soft core hay bales, the inside edge of the bale often interfered with the right side of the operator's cab (FIGURE 2). Modifications are recommended to eliminate this interference as damage to the operator's cab side window occurred on four occasions.

FIGURE 2. Bale Interference with the Operator's Cab while Loading 72 in (1830 mm) Soft Core Hay Bales.

- It is recommended that the manufacturer consider:
1. Modifications to eliminate bale interference at the operator's cab side window while loading large, soft core hay bales.
  2. Modifications to the load deck and rear tailgate to properly accommodate eight, 72 in (1830 mm) diameter bales.
  3. Modifications to the gear shift lever and foot throttle location to eliminate operator fatigue.
  4. Supplying an accurate coolant temperature gauge.
  5. Modifications to the rear view mirror location to eliminate cab door interference and to improve rear visibility.

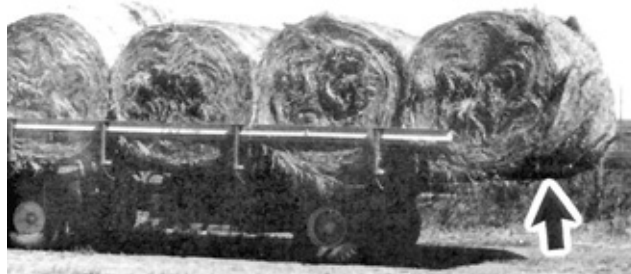
**Load Quality:** The New Holland 8500 formed a durable load which transported well with little shifting or settling. Material loss during transporting was negligible. When handling 72 in (1830 mm) diameter bales, the tailgate was forced partially open during the last cycle of the pusher (FIGURE 3). The partially opened tailgate did not affect load quality. However, to ensure safe road transport, modifications to permit adequate accommodation of eight, 72 in (1830 mm) diameter bales are recommended.

FIGURE 3. Partially Opened Tailgate when Loaded with Eight, 72 in Diameter Bales.

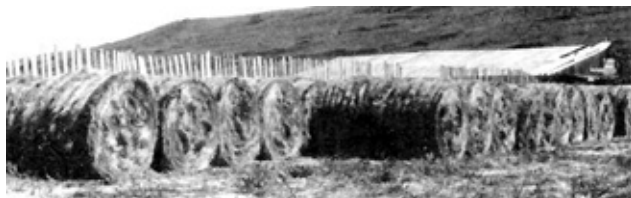
**Placement Quality:** Placement quality was good with solid, well formed bales (FIGURE 4). The New Holland 8500 placed bales in two rows with the circumferences of each bale touching in each row. Bale spacing was not possible within each load. Adjacent loads, however, could be easily spaced according to operator preference. An experienced operator could place adjacent loads together forming uniform rows of tightly spaced bales.

FIGURE 4. Bale Placement with New Holland 8500.

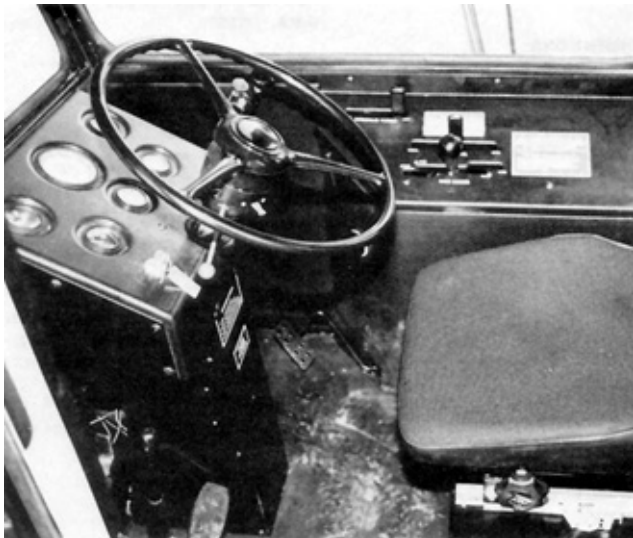
**Instruments and Controls:** FIGURE 6 shows the instrument and control arrangement of the New Holland 8500 operator's cab. Loader and load deck controls were easily accessible from the operator location. Visibility of the loader was very good. The gear shift lever and foot throttle were inconveniently located. The operator had to reach forward to shift gears while maintaining an awkward leg position. Operator fatigue occurred after several hours. Modifications to the gear shift lever and foot throttle locations are recommended.

The instruments were located on a console in front of the operator. Gauges were provided for coolant temperature, battery voltage, oil pressure, fuel level and ground speed. An hour meter registered the amount of time the ignition switch was on. The coolant temperature gauge indicated overheating at normal operating temperatures. It is recommended that an accurate gauge be supplied.

FIGURE 6. New Holland 8500 Instrument and Control Arrangement.

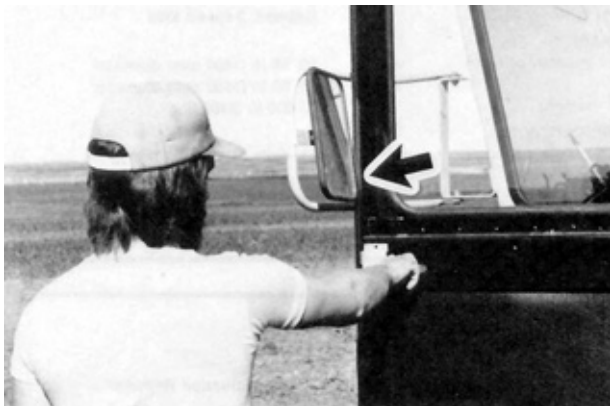
The rear view mirror provided poor rear visibility when loaded. Interference between the cab door and mirror (FIGURE 7) prevented the door from completely opening. Modifications to the rear view mirror location are recommended to eliminate door interference and to improve rear visibility when loaded.

FIGURE 7. Interference between Rear View Mirror and Cab Door.

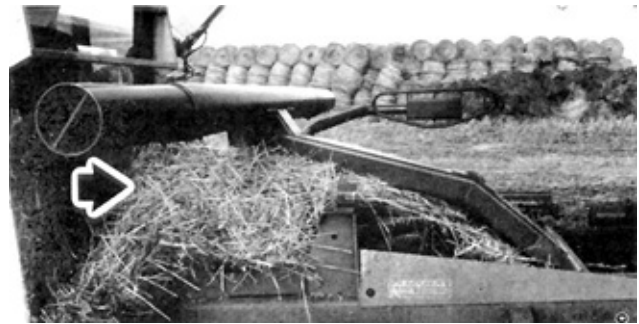
Loose material often collected below the pusher (FIGURE 8). Pusher operation was not affected but excessive build-up required occasional removal.

FIGURE 8. Collection of Loose Material below Pusher.

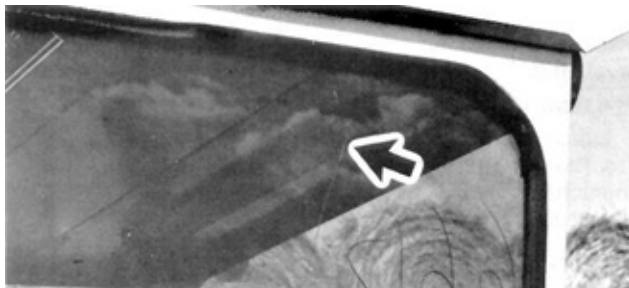
**Cab Side Window:** The right operator's cab window broke (FIGURE 12) due to bale interference when loading large, soft core bales.

FIGURE 12. Damaged Cab Window.

- With regard to recommendation number:
1. A soft core bale loading kit has been designed and is offered as an attachment.
- 2, 3, 4 and 5.
- These recommendations will be taken under advisement by our Engineering Department for future consideration.
